DAMALANCHE: AVALANCHE DAMMED RIVER

Sarah Carter¹ and
Peter Carter²

¹Valdez Avalanche Center, Valdez,
Alaska

²Alaska Department of
Transportation,
Thompson Pass, Alaska

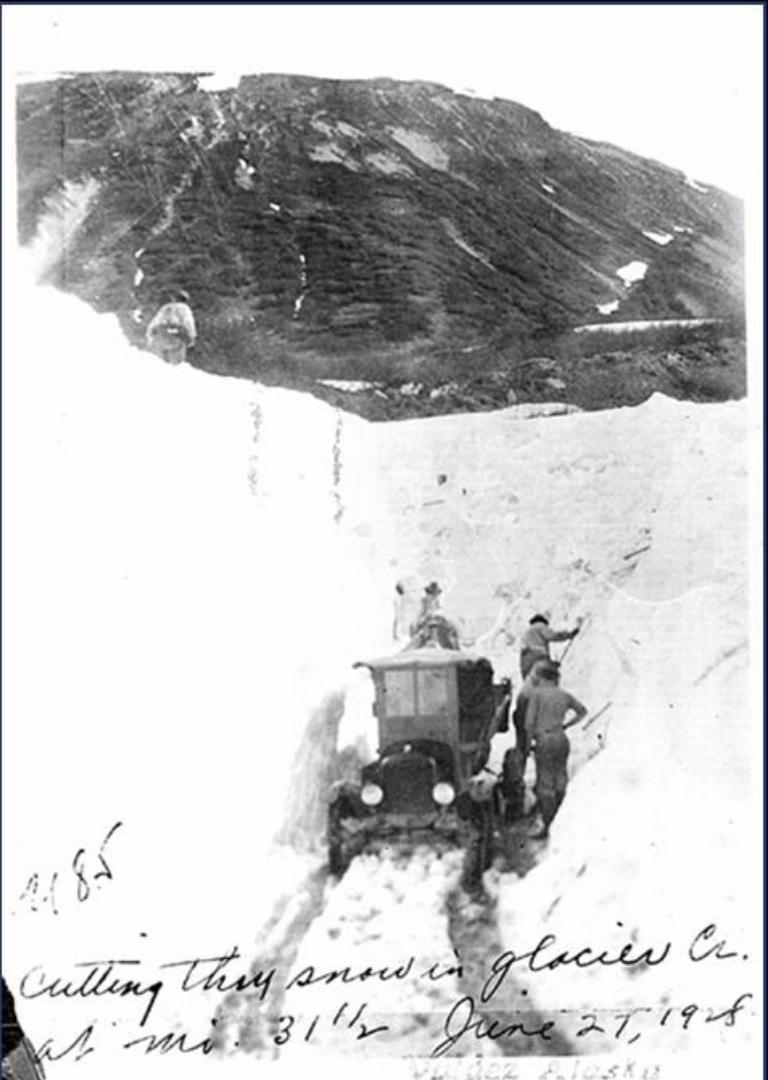
4185

Cutting thru snow in glacier Cr.
at mi. 31 1/2 June 27, 1928

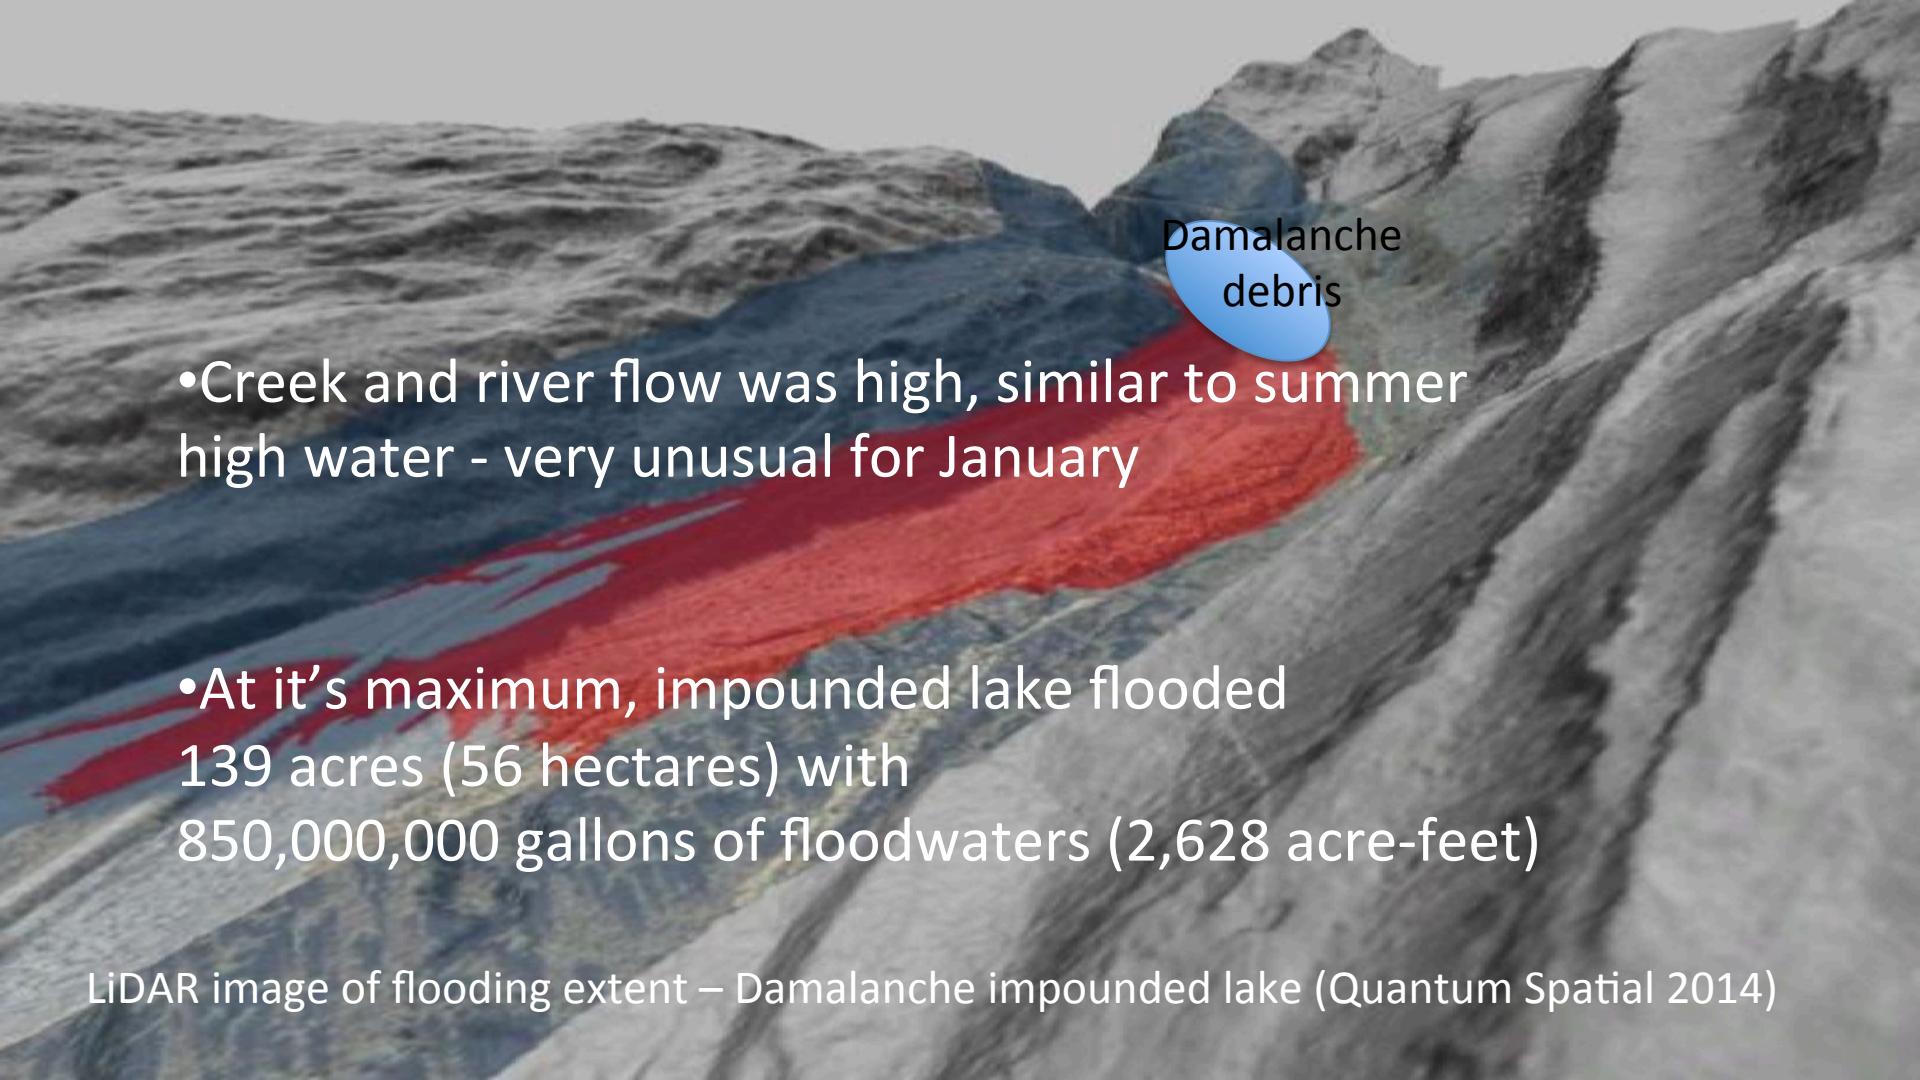
- Creek and river flow was high, similar to summer high water - very unusual for January
- At its maximum, impounded lake flooded 139 acres (56 hectares) with 850,000,000 gallons of floodwaters (2,628 acre-feet)

LiDAR image of flooding extent – Damalanche impounded lake (Quantum Spatial 2014)

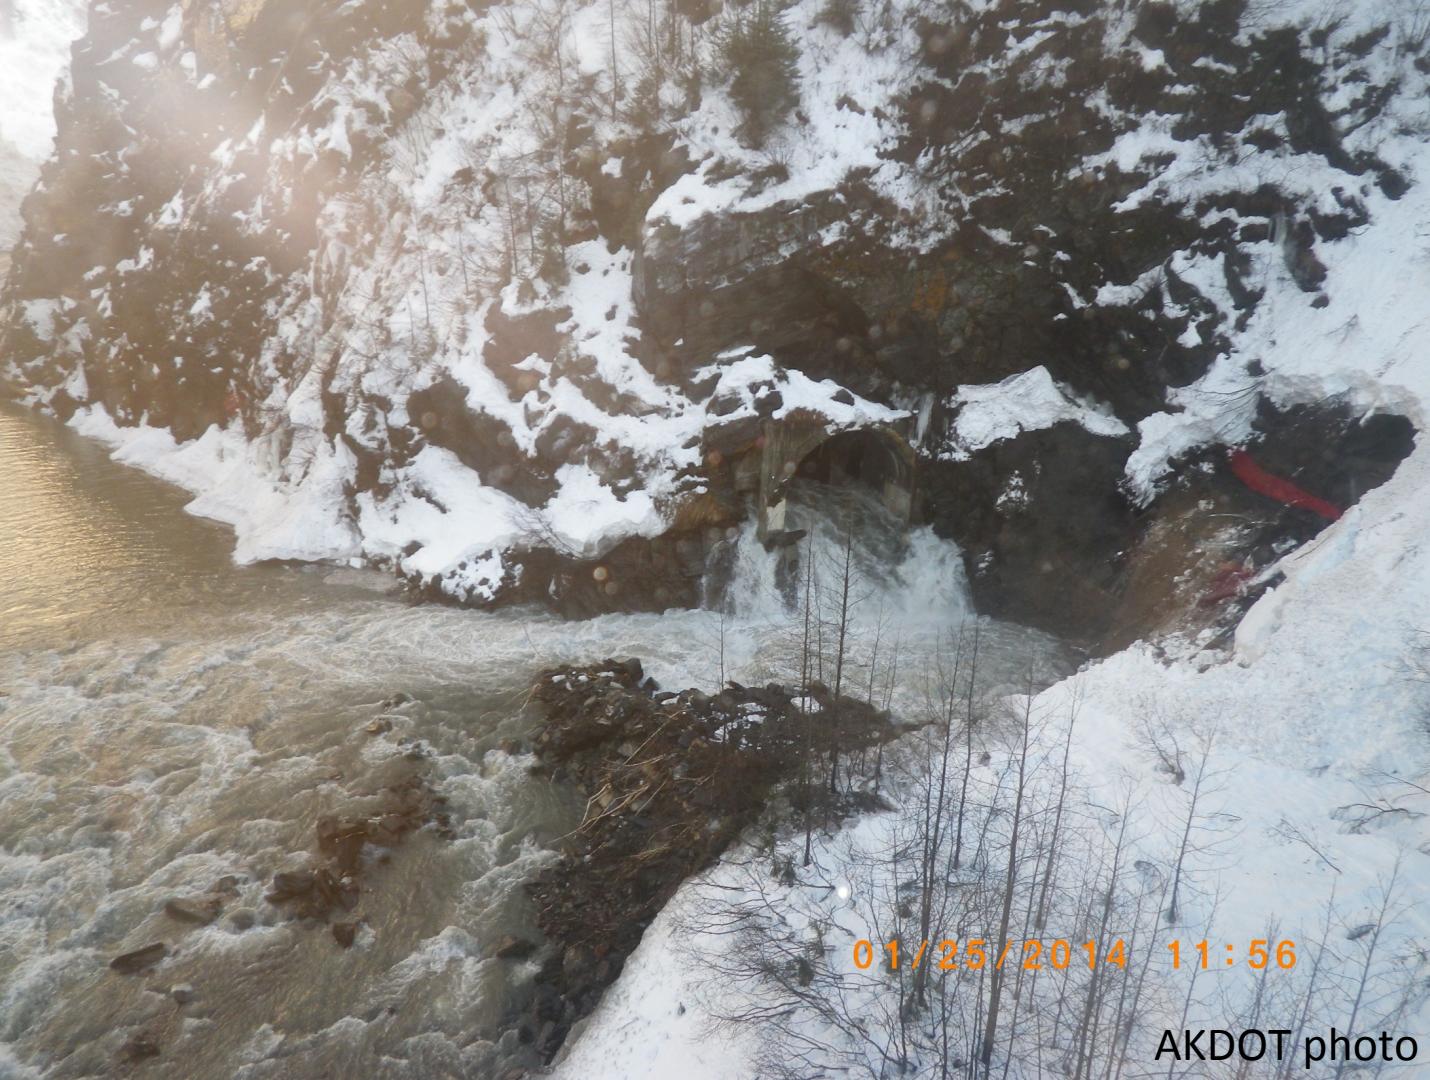
The concern was rapid or catastrophic breach of the avalanche dam.

Water found a hydraulic pathway in the form of an old highway tunnel to drain lake.

Seven day flash-flood advisory for downstream neighborhoods.

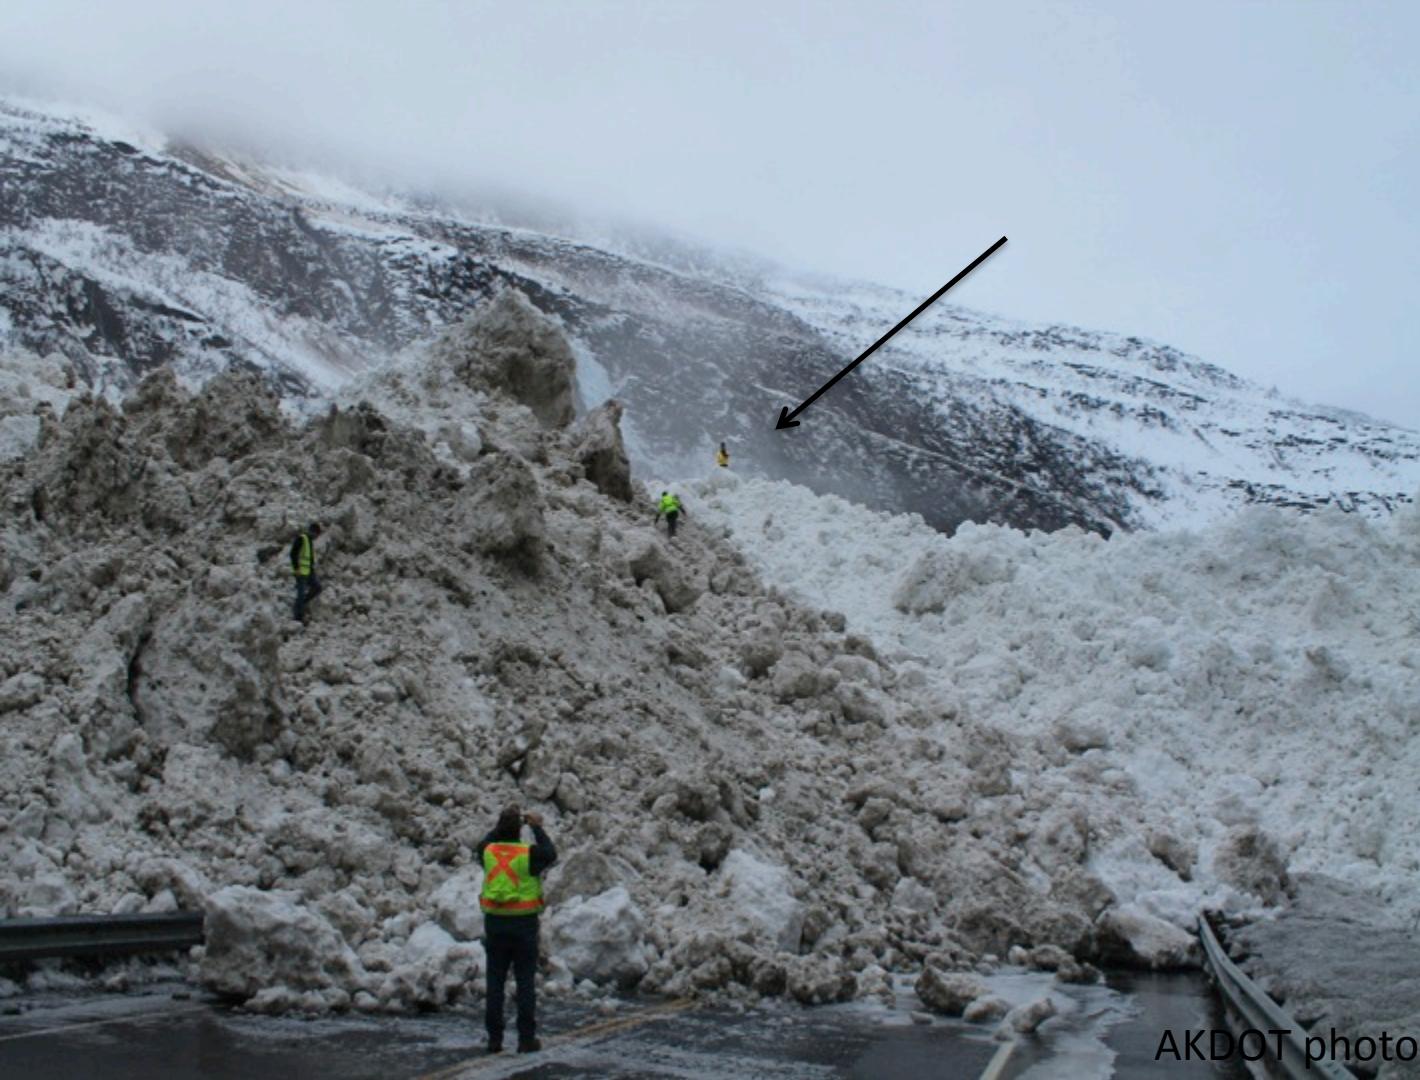
AKDOT crew
assessing
size and extent
of Damalanche

2000' road
buried
Avg. depth 75'
Max. depth 140'

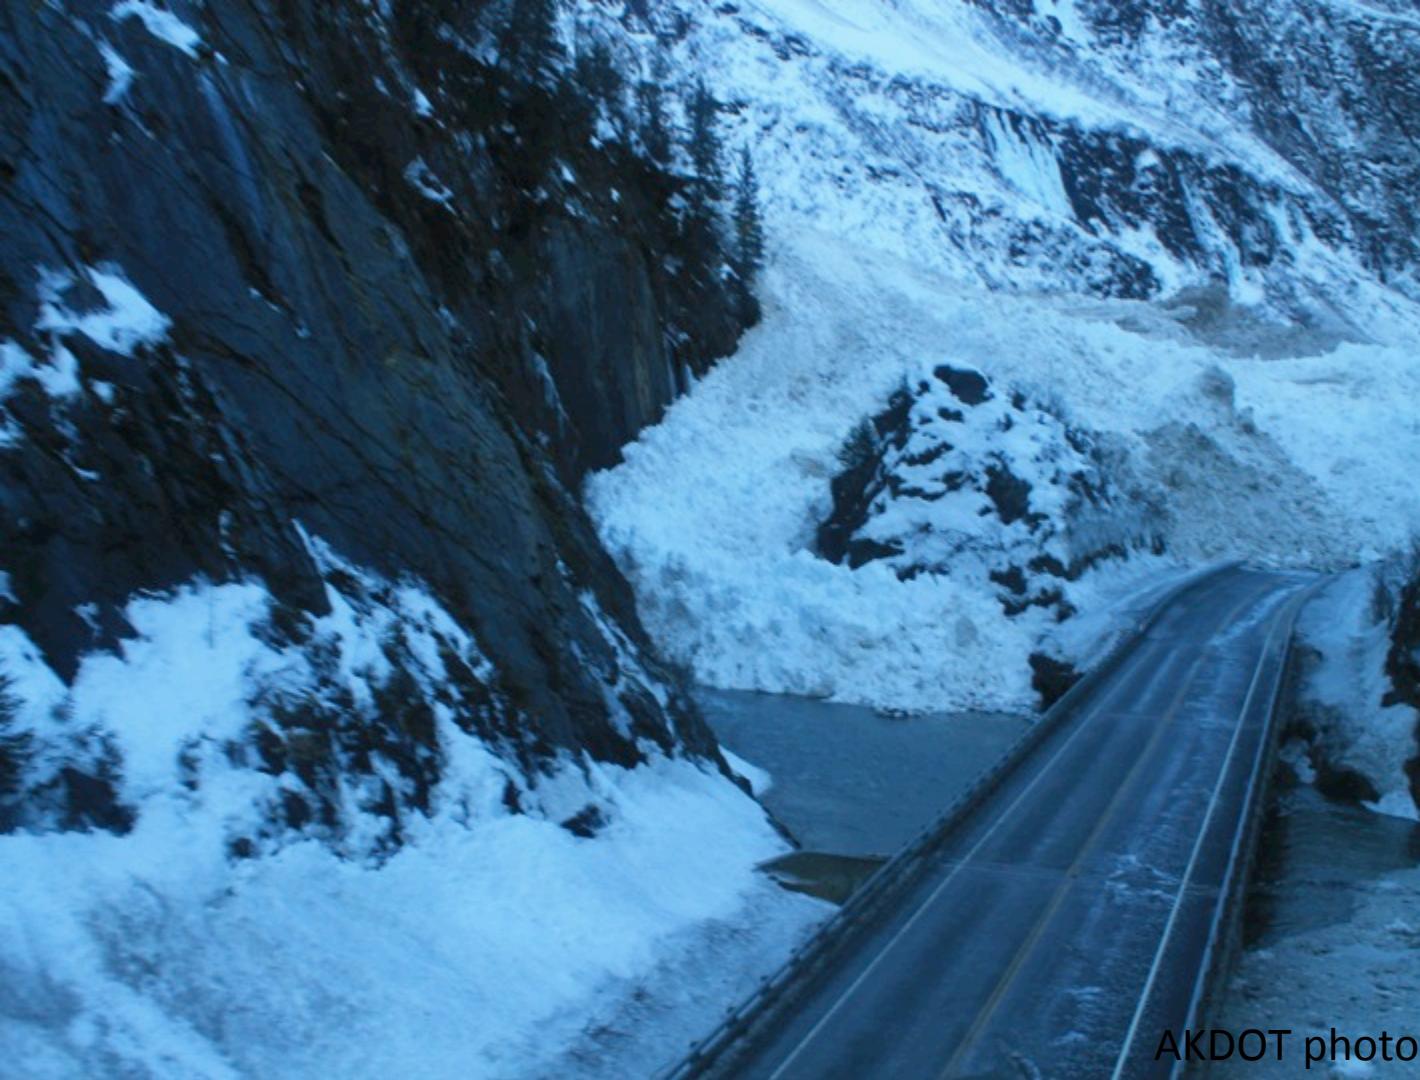
View of
Damalanche
from
Keystone Canyon

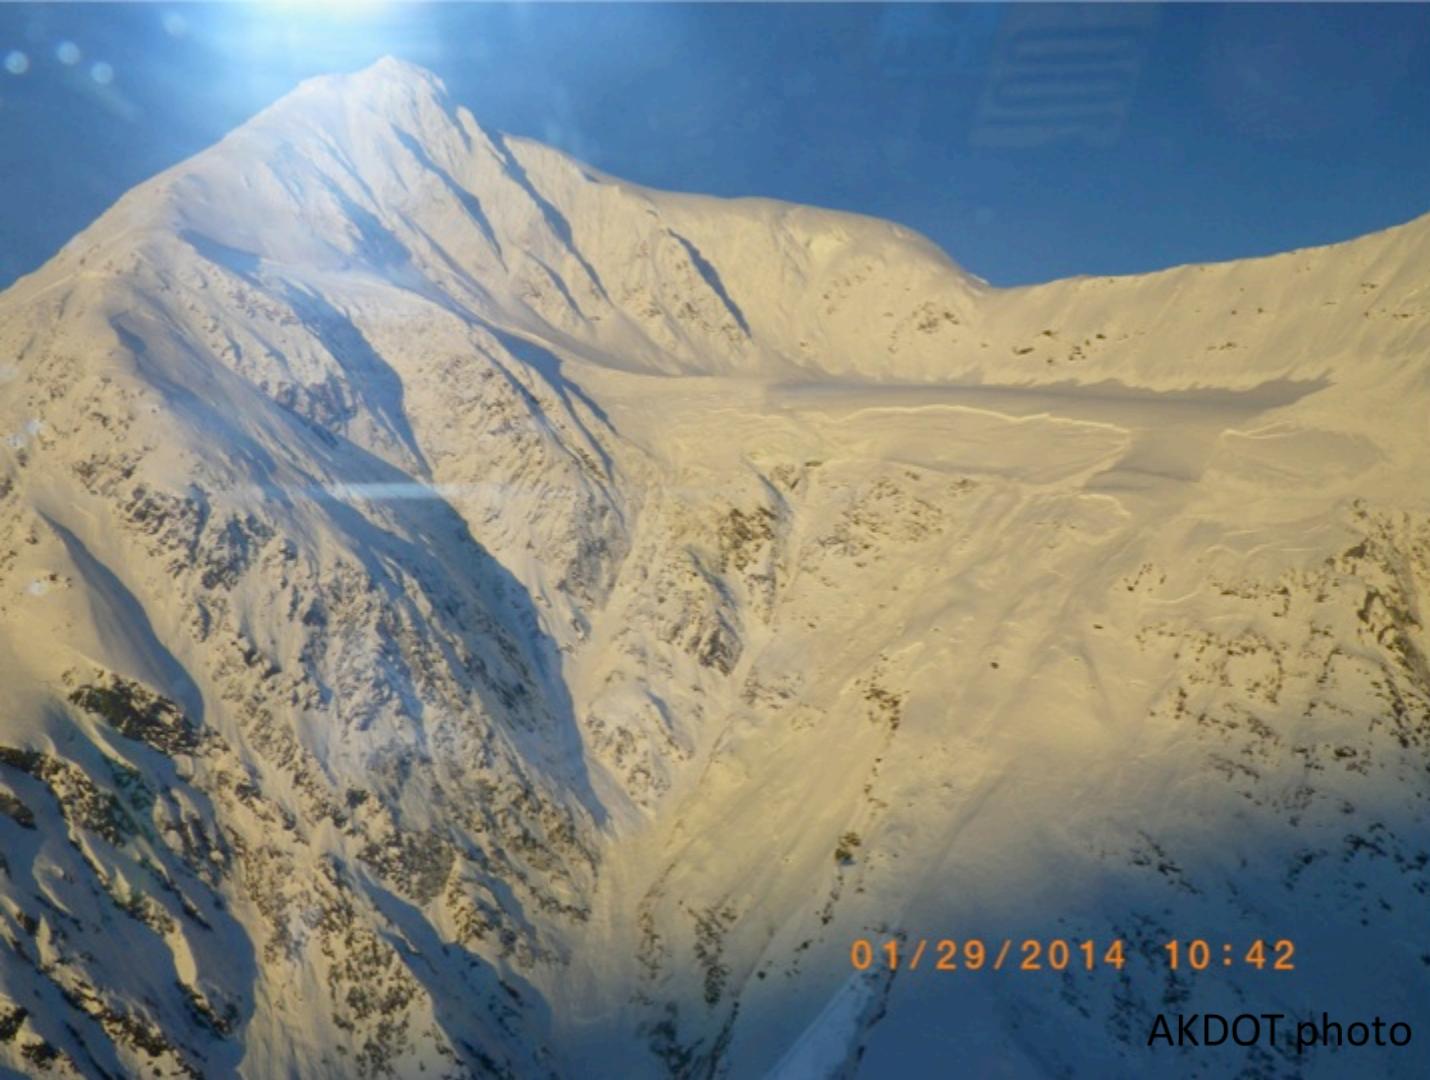
Full depth
Fracture lines
~12' (4m)
Sympathetic
avalanches
down to glacier
Ice from AKDOT
heli bombing –
January 25, 2014.

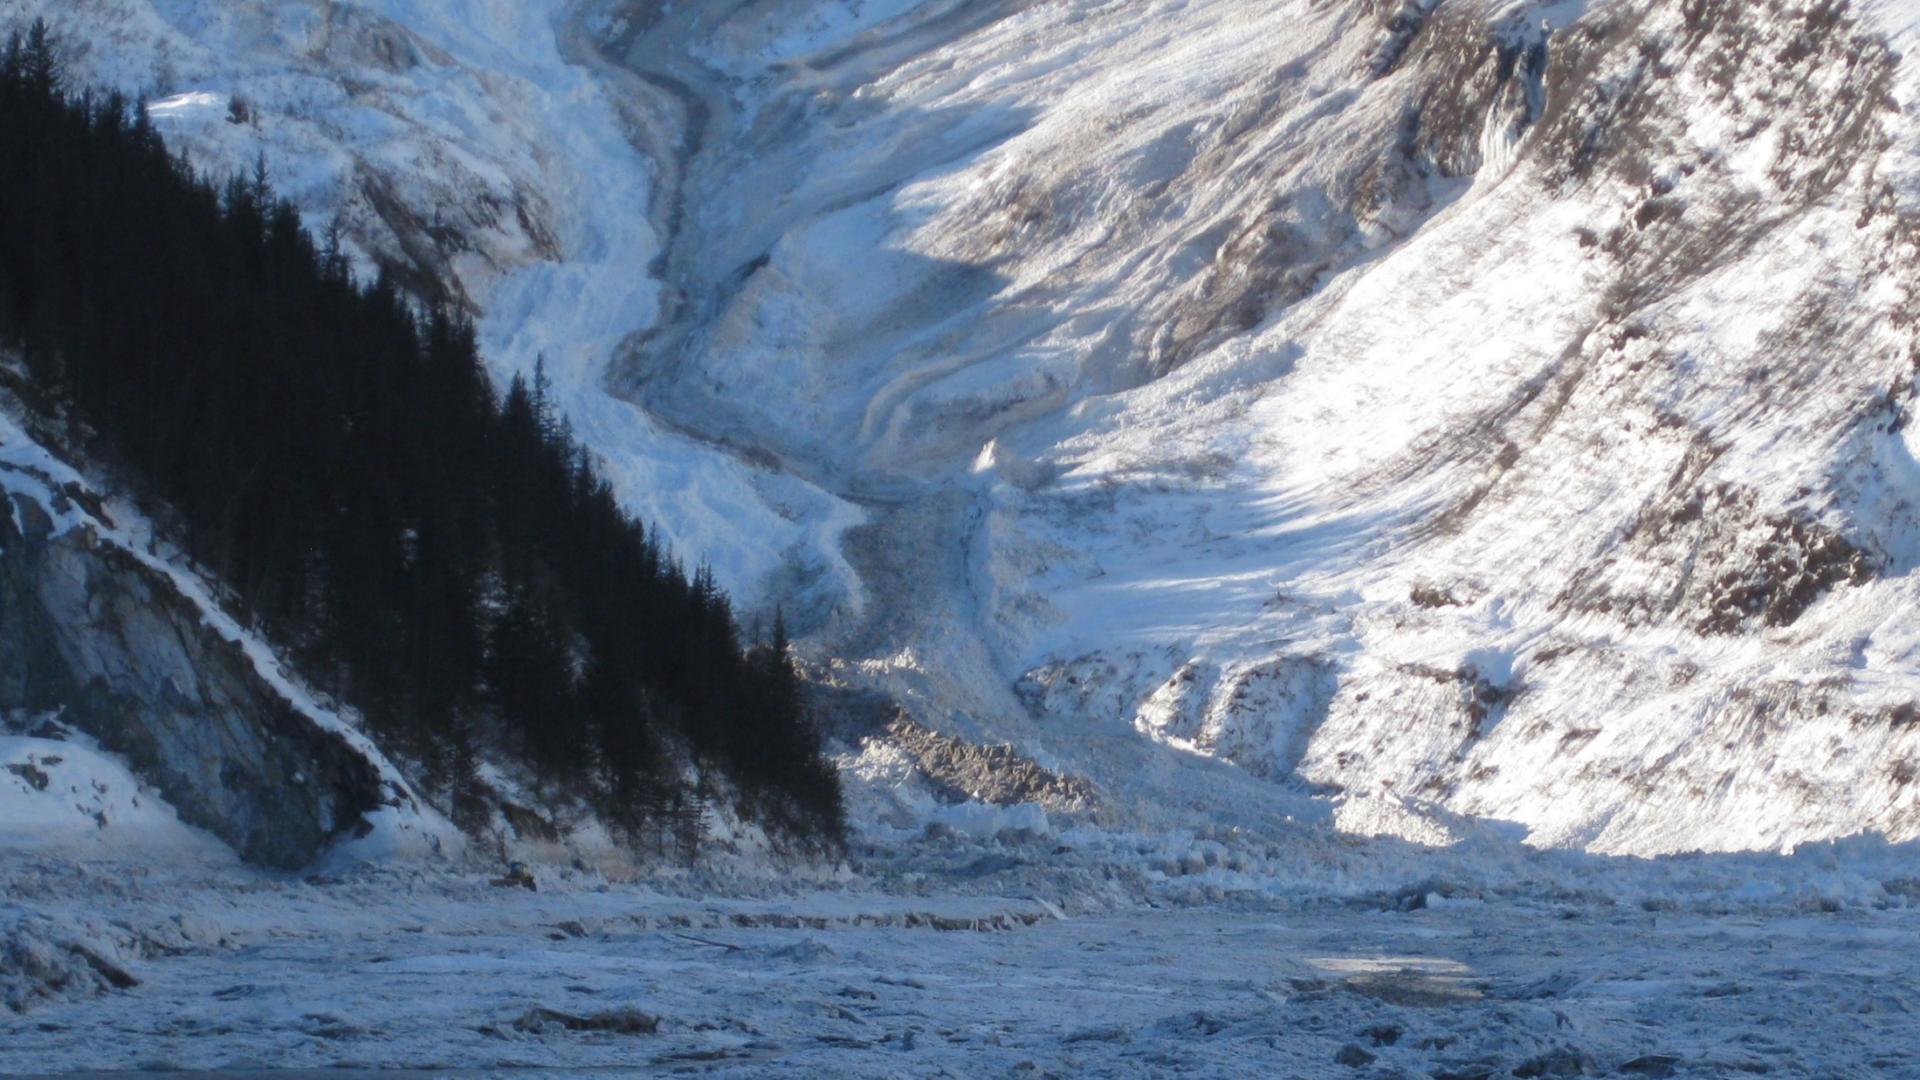
Widespread Cycle
Wet avalanches
behind the town
of Valdez
January 2014

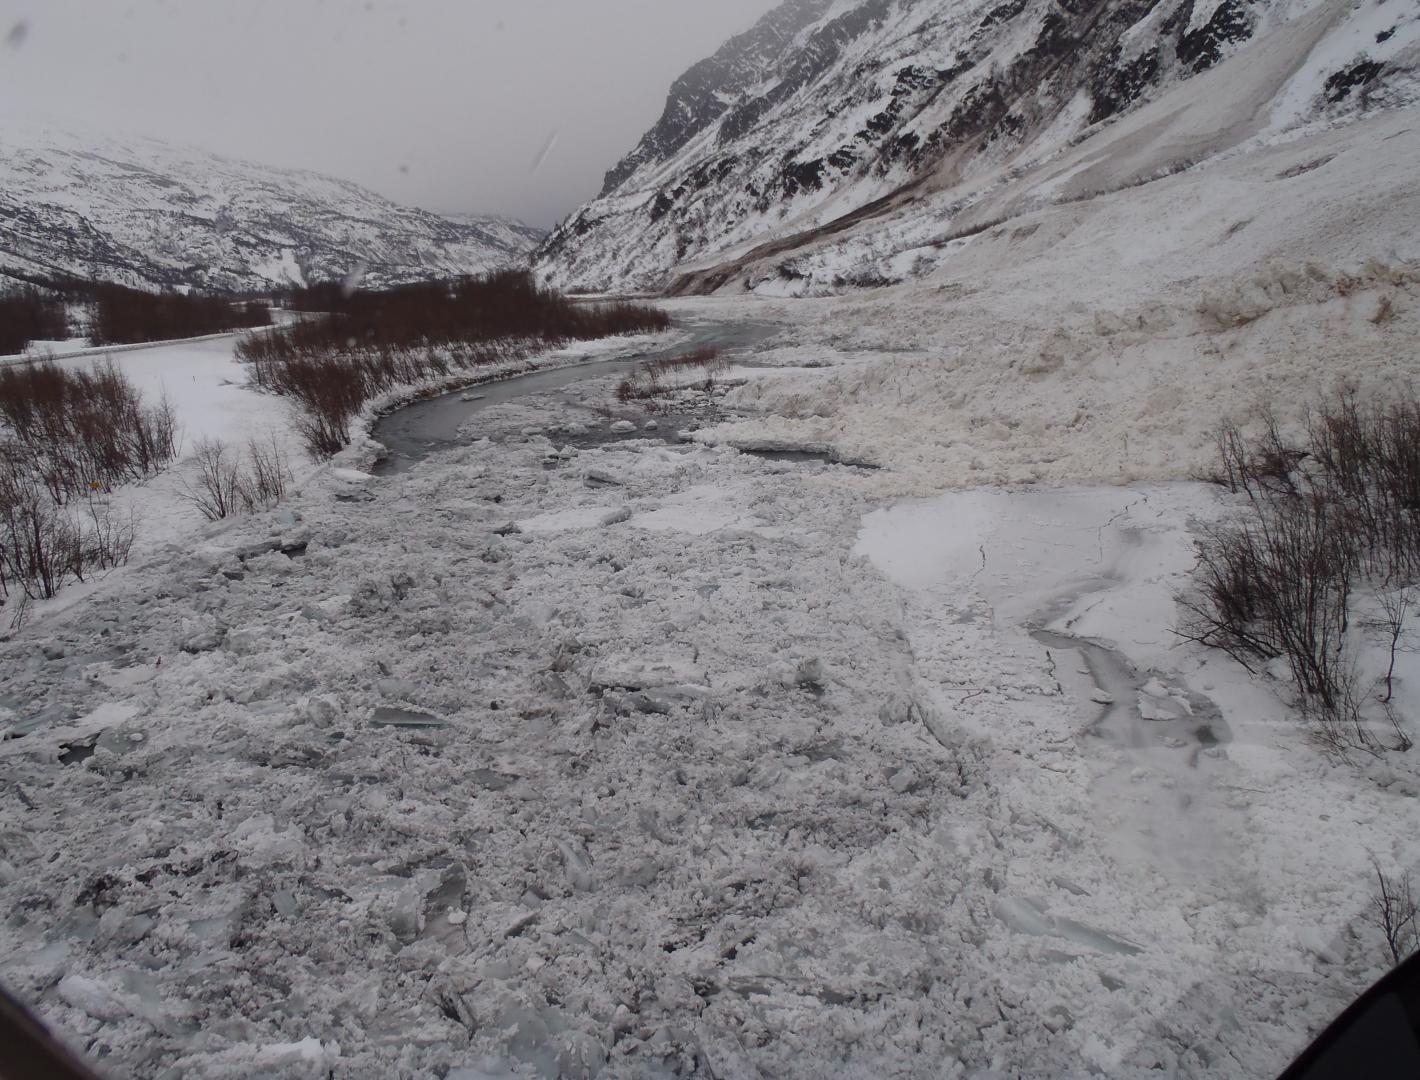
Wet avalanches
Filling up and
Blocking the
Tsaina River
January 2014
